# Slope protection with an earth retaining system: respectful of natural resources and the landscape

Steve Gruslin<sup>1\*</sup> and Domenico Nola<sup>1</sup>

Heavy rains in June 2018 damaged a road between Echternach and Berdorf (Luxembourg) so severely that it had to be closed. The river along the road below it destroyed the existing stabilisation structures, such as retaining walls and gabion walls, and severely eroded the natural slope covering the underlying Luxembourg Sandstone. Water infiltrated the embankment, causing landslides extending in several places to below the body of the roadway. After clarifying the geological situation and determining the geotechnical parameters of the materials, renovation was carried out using natural materials present on the site, which were used to recreate load-bearing structures reinforced by geogrids and adapted to the landscape in topographically very difficult conditions. From a sustainability standpoint, landslide materials and locally excavated materials were reused in a resource-saving manner.

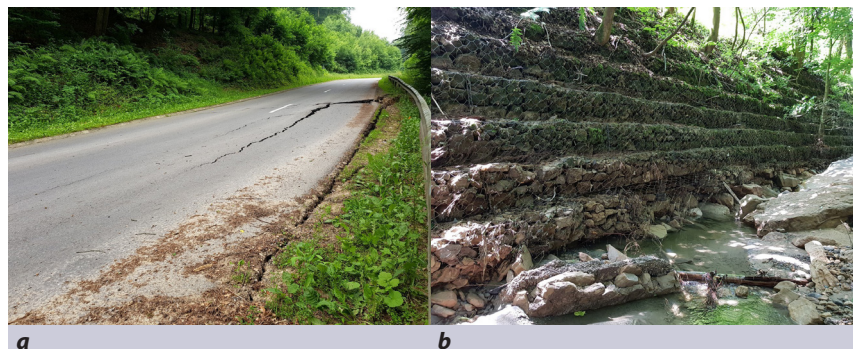
Figure 3: Examples of damage: cracks on the road (a); damaged gabion retaining wall (b).

This area suffered a significant slip of the slope under the road (Figure 3a), causing it to crack. In addition, a bridge on the hiking trail over the Aesbach was completely destroyed. The lower part of the slope also shows strong traces of scour and erosion due to the force of the stream.

West of the site the slope was stabilised by gabions. Because of the speed and increased density of the stream due to sediment, floating debris and boulders that were transported, the gabion wall present over part of the area was undermined and considerably damaged (Figure 3b). The lower layer, which forms the basis of the entire retaining structure, was particularly

affected. The road was affected by numerous longitudinal cracks due to the loss of wall integrity and landslides.

The water masses resulting from the heavy rains coming from the hill above the site reached the road, ran off on the embankment and caused significant erosion on the surface. The water which penetrated under the road quickly crossed the permeable layers (backfills and scree) and mobilised the sliding surface constituted by the Rhaetian layers, so that all the embankments and scree slipped, which led to the appearance of cracks in the roadway. Reconnaissance boreholes allowed us to estimate that around 10,000 m<sup>3</sup> of underground materials had slipped. Figure 4 shows the cause of the damages, interpreted using the results of the exploration boreholes and the position of the cracks (GEOCONSEILS S.A., 27/09/2018; 2019).

In order to find a sustainable solution and to protect the road against future heavy rains, the damaged existing embankment, which already had very steep slopes, was replaced by a steep embankment made of natural materials reinforced by geogrids that fits perfectly into the landscape.

Extensive geotechnical studies and calculations have shown that landslides can reoccur in affected areas if only limited corrective measures are put in place near the surface. To avoid long-term instabilities, it was necessary to excavate the entire body of the slip over the entire width of the roadway and down to the layers of Rhaetian at risk of slipping (Figure 5). The curved path of the Aesbach created additional requirements by limiting the space available for the basis of the reinforced earth construction

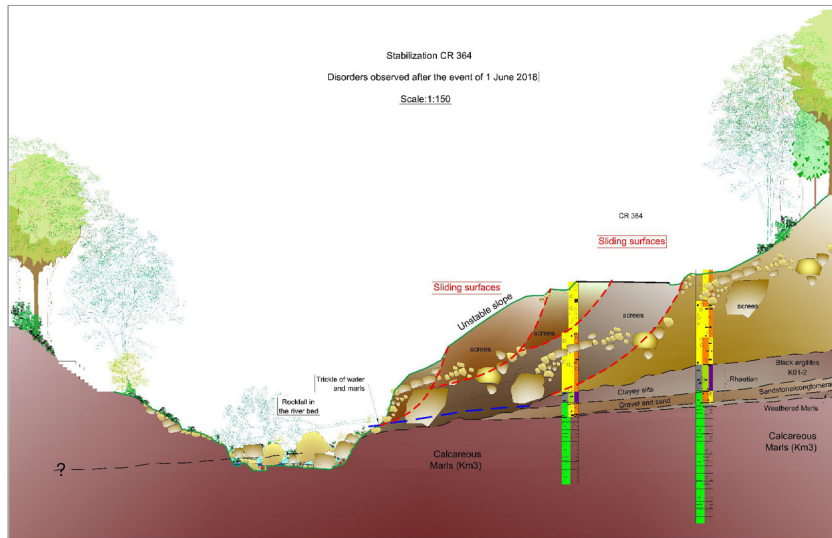
Figure 4: Interpretation of the situation based on the results of the boreholes.

The geotechnical investigations carried out encountered stony and gravelly backfills under the road over thicknesses of up to 3 m. Below there is slope scree consisting of sand and gravel with encrusted and partially altered layers of the Upper Triassic (Rhaetian) and the layers of the Middle Keuper. Rhaetian layers have high consist-

ency in the dry state, but they are very sensitive to water. They soften very quickly on contact with water, thus playing the role of a "soap layer" which, in combination with the inclination of the layer, can constitute a potential sliding surface for overlying materials that are not very cohesive.

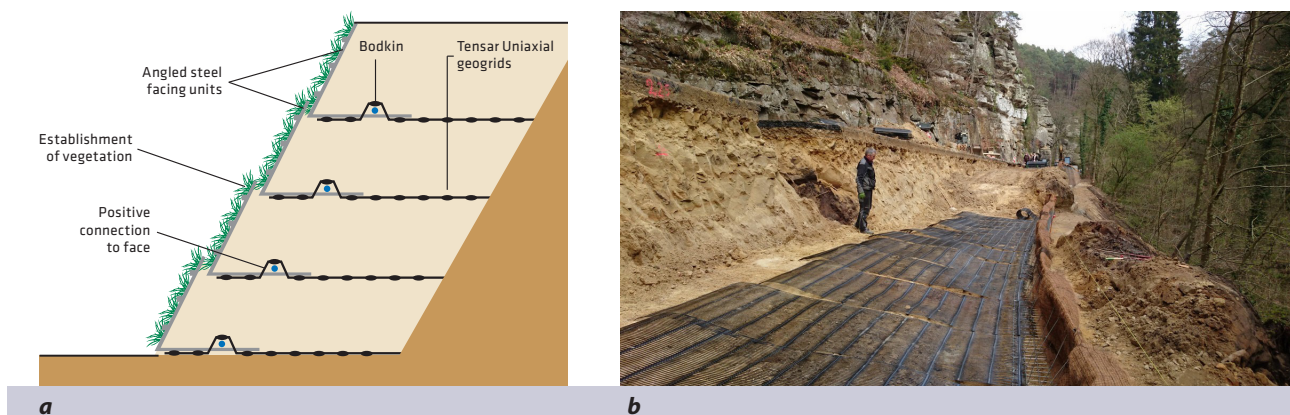
Figure 6: The TensarTech GreenSlope system: its principle (a) [reproduced with the permission of Tensar] and on site (b).

To provide the support structure for the earth retaining system fill sections, the steep slope system TensarTech GreenSlope

was chosen, which allows slopes between 45° and 70° to be created. This system chosen for reinforcement is an adaptable, settlement insensitive securing system made up of steel grid elements in the front and horizontally laid geogrids, so that the backfill material results in a composite load-bearing body with a high degree of ductility.

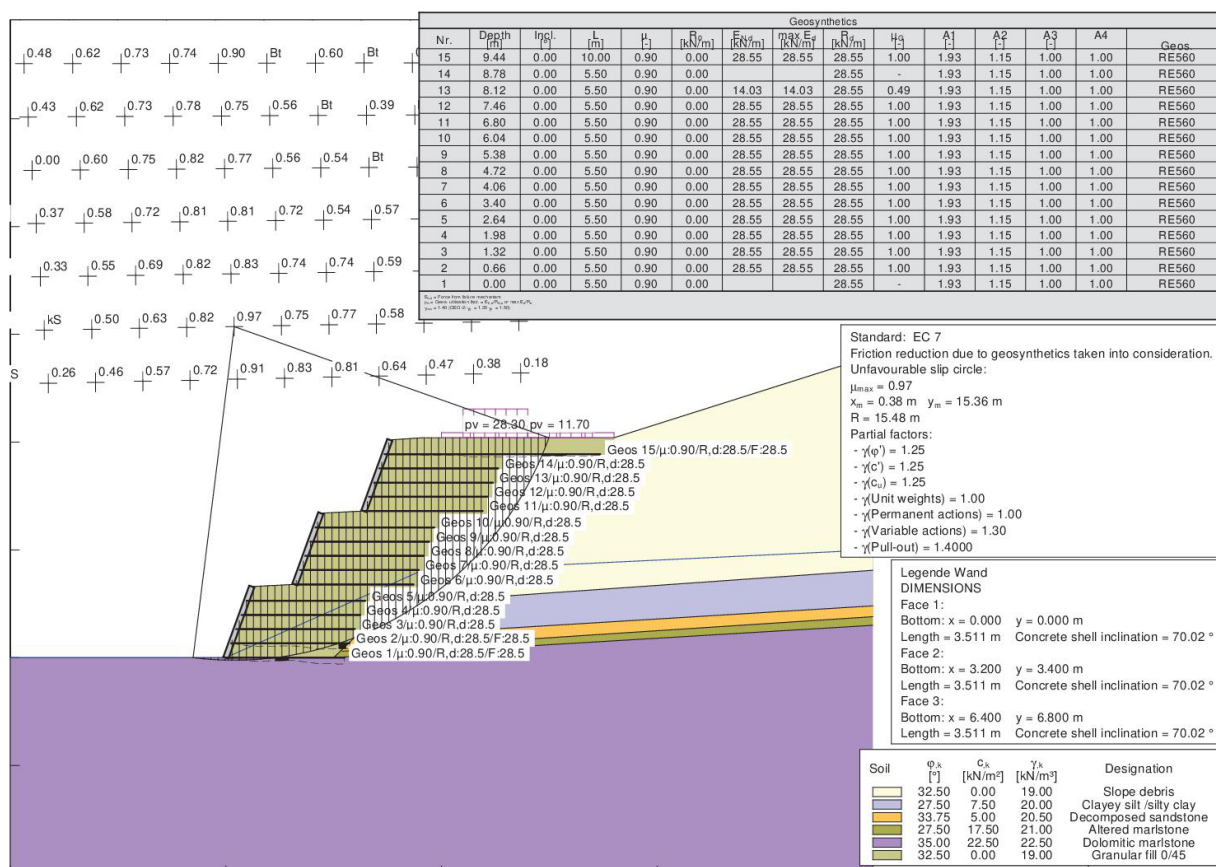
Figure 7: Stability calculations of the reinforced earth system.

Based on stability calculations using geotechnical software, the inclination of the elements made of steel grid is 70° and the distance between the layers of the horizontal geogrids is 66 cm. The reinforcement consists of expandable, uniaxially

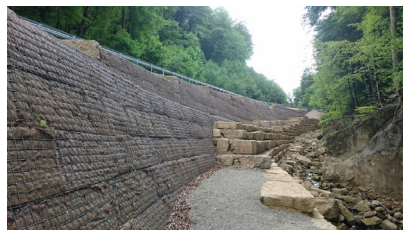
Figure 8: Stabilisation system under construction.

To take into account the uneven topography of the site, the reinforced earth construction was built to heights of between 3 m and 9 m. In order to obtain a uniform landscape, berms of about 2 m in width were built every 3 m high. Thanks to the combination of the green construction in reinforced earth, the section of road blends harmoniously into the landscape since the end of the works in summer 2019. *Figure 8* shows the reinforced earth construction under construction in April 2019 (Meyer *et al.*, 2019).

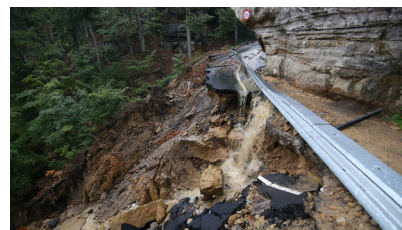
Figure 9: Landslide at the "Preacher's Chair".

The 2<sup>nd</sup> zone is located in the western part of the damaged road, approximately 50 m higher than damaged zone 1. In this area, the road embankment was also considerably eroded by heavy rains and water seeping into the embankment destabilised the road and caused landslides in several places. The largest landslide affected the tourist area known as the “Preacher’s Chair”.

In this location, the waters of the stream are channeled under Route CR364. Due to the debris carried during the storm, the existing pipes were blocked and could not handle the volume of water associated with the severe weather. Consequently, the water overflowing from the pipeline seeped into the embankment of the road, creating a large landslide which locally washed away all the CR364 road. Each subsequent rainfall further accentuated the instabilities created by the June 2018 storm.

ered and unweathered. The landslides were therefore caused by the large amounts of water seeping through the non-cohesive screes, which, combined with the steep slope, created the movement (GEOCONSEILS S.A., 17/10/2018).

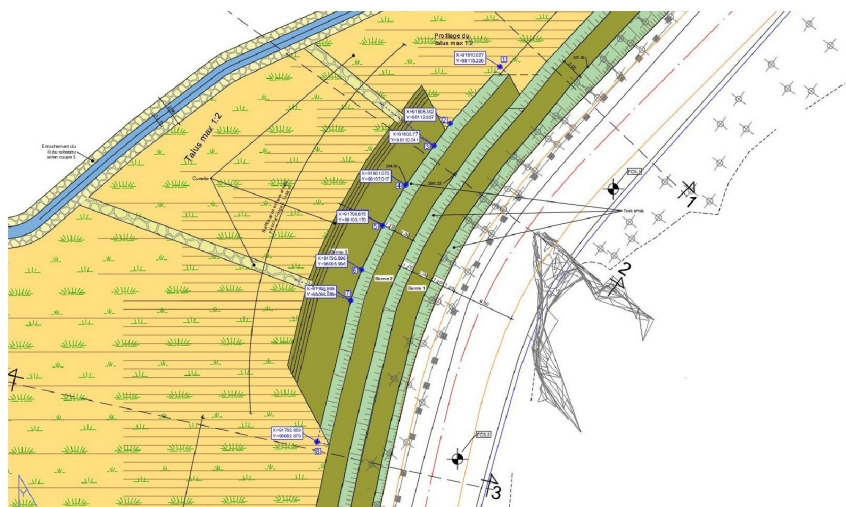
Figure 10: Situation map of the reinforced earth construction at the “Preacher’s Chair”.

Similarly to the Zone 1 renovations described above, the entire slip body was excavated, and a geogrid reinforced earth system (Tensar Tech GS System) was implemented (*Figure 10*).

Here also, material excavated from the slipping zone was treated on site and reused as backfill material. The variable geometry of the valley required an adjustment of the height, which results in different heights of the reinforced earth structure and the creation of 2 m wide berms. The retaining structure therefore fits harmoniously into the landscape.

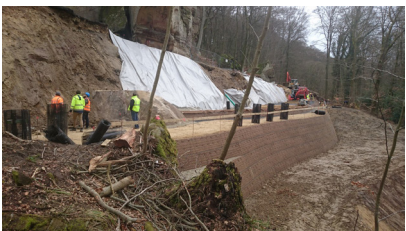
Figure 12: Rock outcrop integrated into the stabilisation system.

In addition to the topography of the valley, the highly variable geometry of the rock that outcropped after the excavation of the landslide zone created an additional constraint. In several places, rock points protruded into the retaining structure, similar to those visible above road level at the "Preacher's Chair". *Figure 12* shows the state of construction in April 2019. A rock outcrop integrated into the exterior face of the backfill is visible (Meyer *et al.*, 2019).

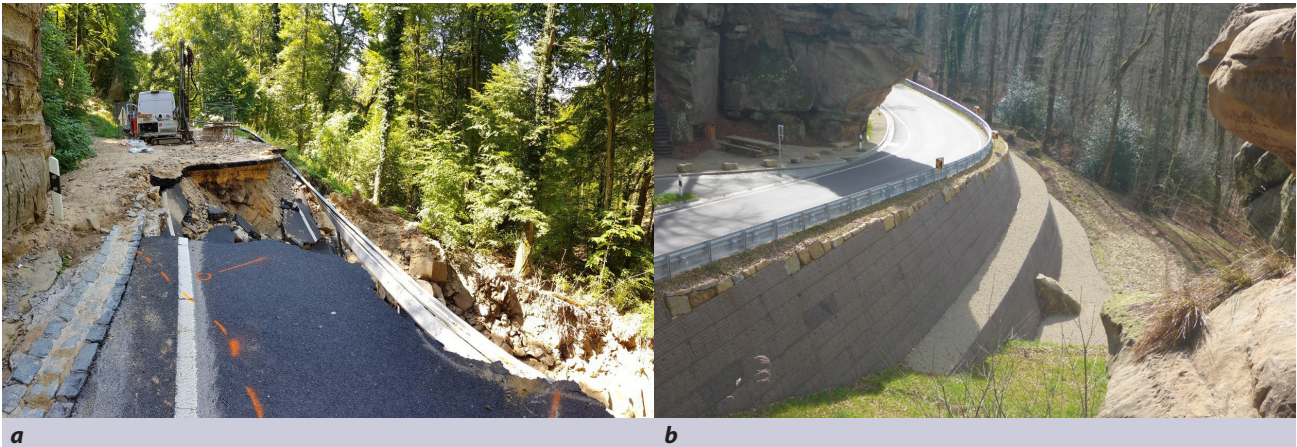
Figure 13: Situation before (a) and after (b) stabilisation.

A comparison between the initial situation after the landslide and the final situation is visible in *Figure 13*. The entire slope

will be covered in vegetation soon, because the TensarTech GreenSlope system will promote vegetation growth on the surface, helping it to blend in with its surroundings.
